**Visual Simulation 1:  
Western Corridor from Upper  
Thumb Picnic Area at Peña  
Blanca Lake Recreation Area.**

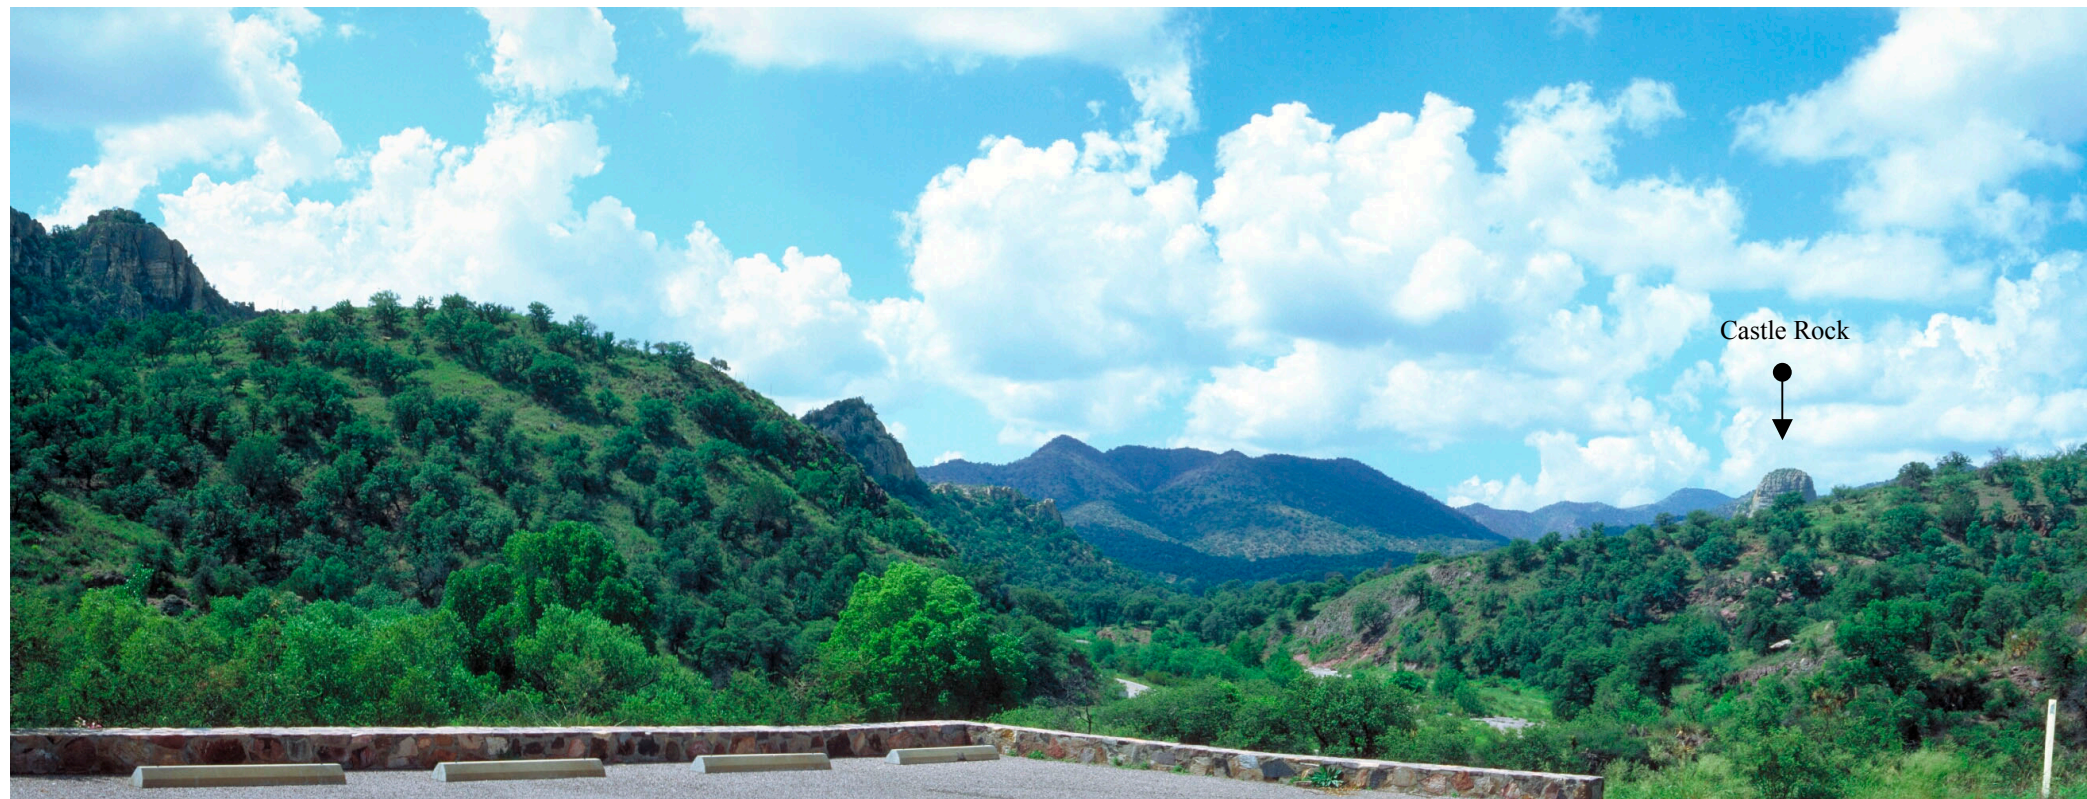
Existing Conditions: View from Upper Thumb Picnic Area looking down Peña Blanca Canyon towards Castle Rock.

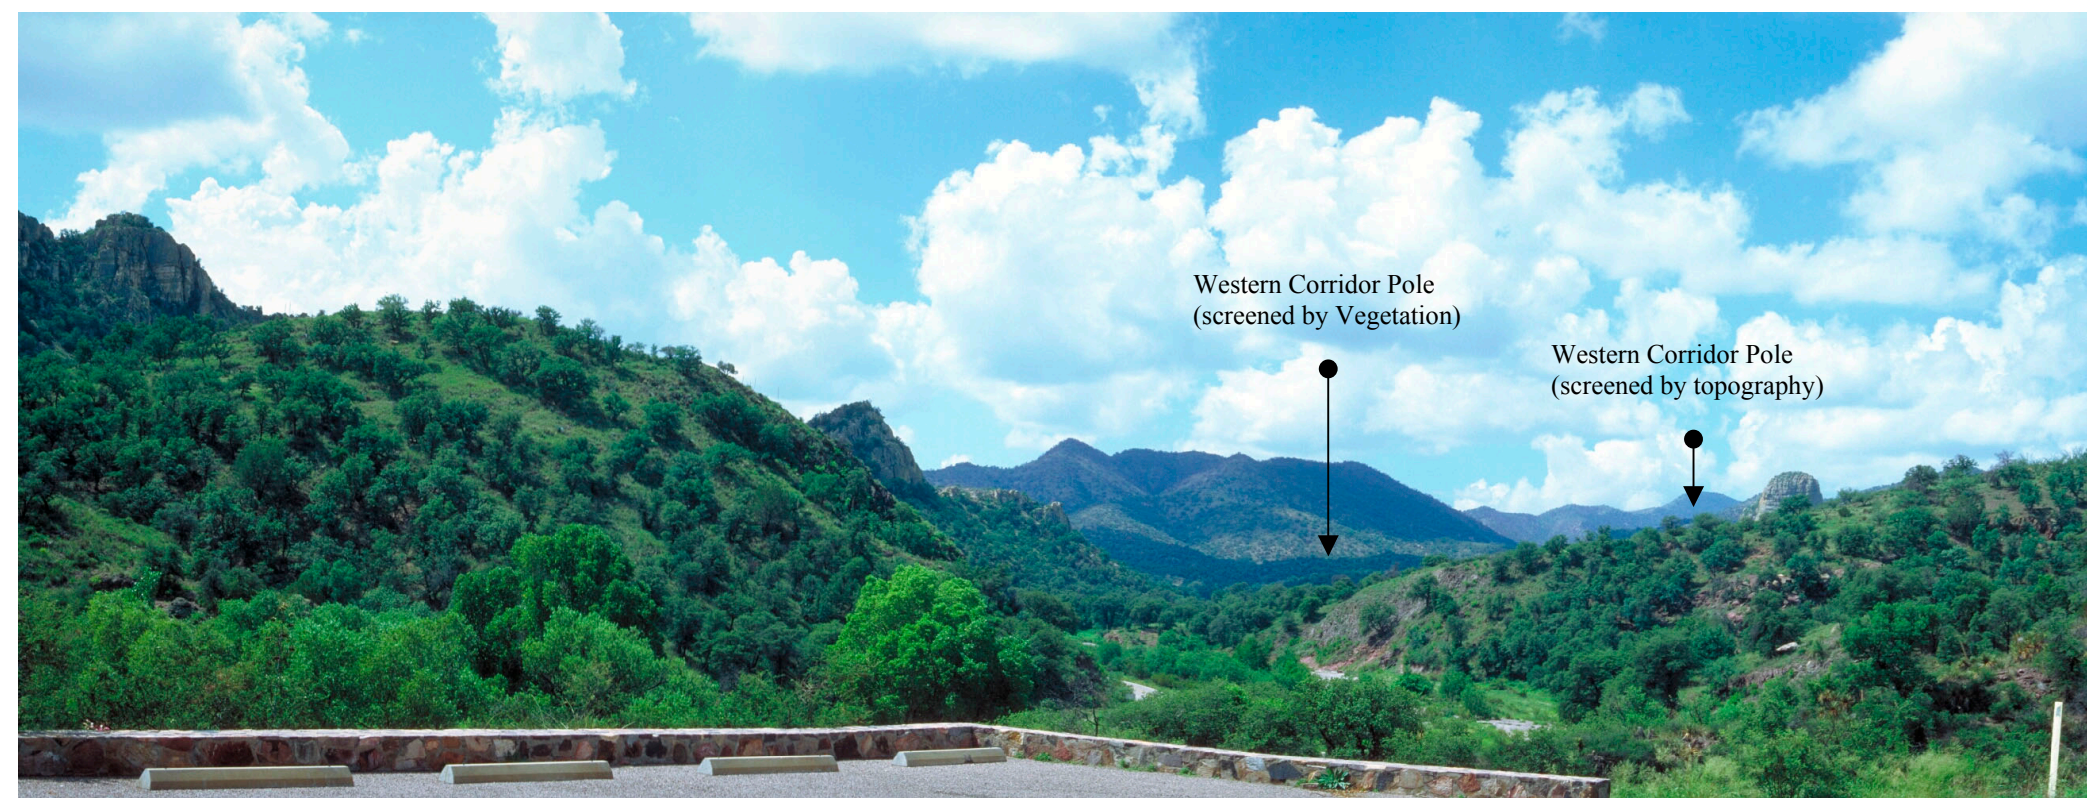
An example, partially-blocked view  
of the Western Corridor from a  
Concern Level 1 travelway.

**Direction:** Southwest

**Distance to Nearest Pole:** 1.2 mi

Visual Simulation: Depicting self-weathering monopoles.
